Report No. 080/01

**Principal:** Schroff GmbH  
Langenalber Str. 96-100  
D-75334 Straubenhardt

**Inspection order:** Mechanical charges, climate tests

**Tested Item:** Outdoor Cabinet 2000x700x700mm

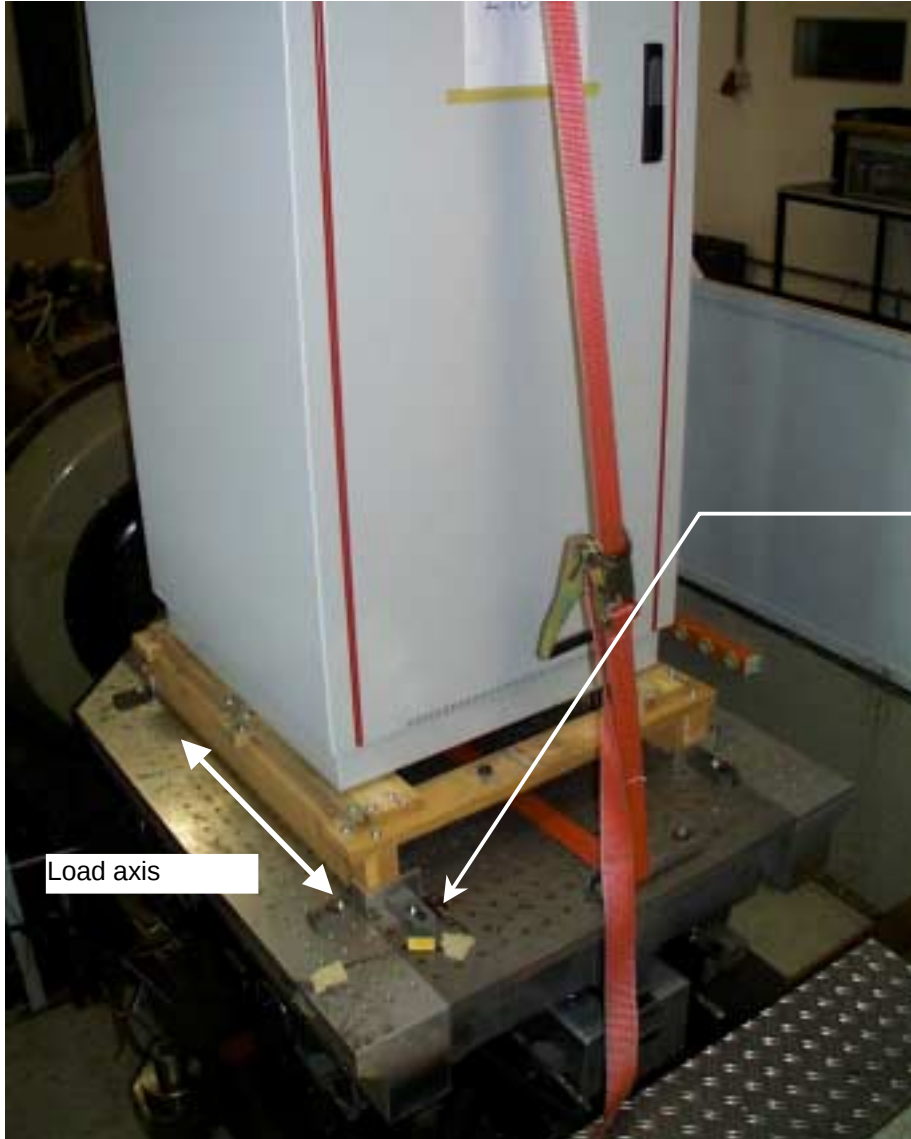
Picture 1

| Test | Ref. | Axis/Set-up | Type of Strain / Remarks | Time / Doc. |
|---|---|---|---|---|
| # 1 | 2.1 | X axis<br>(Picture 1) | Vibration - sinusoidal, 10 cycles<br>Acceleration procedure control channel | 2:23:41 h<br>Enclosure 1 |
| Visual control inside and out<br><u>Result:</u> No damage detectable | | | | |

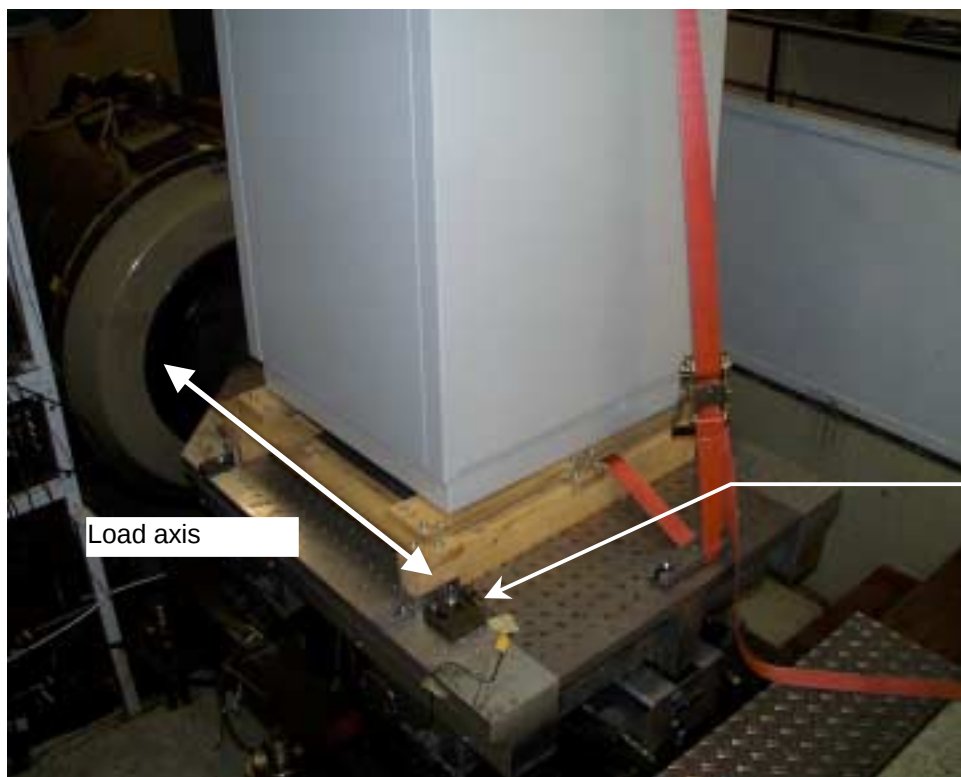
Picture 2

| Test | Ref. | Axis/Set-up | Type of Strain / Remarks | Time / Doc. |
|---|---|---|---|---|
| # 2 | 2.1 | Y axis<br>(Picture 2) | Vibration - sinusoidal, 10 cycles<br>Acceleration procedure control channel | 2:23:41 h<br>Enclosure 2 |
| Visual control inside and out<br><u>Result:</u> No damage detectable | | | | |

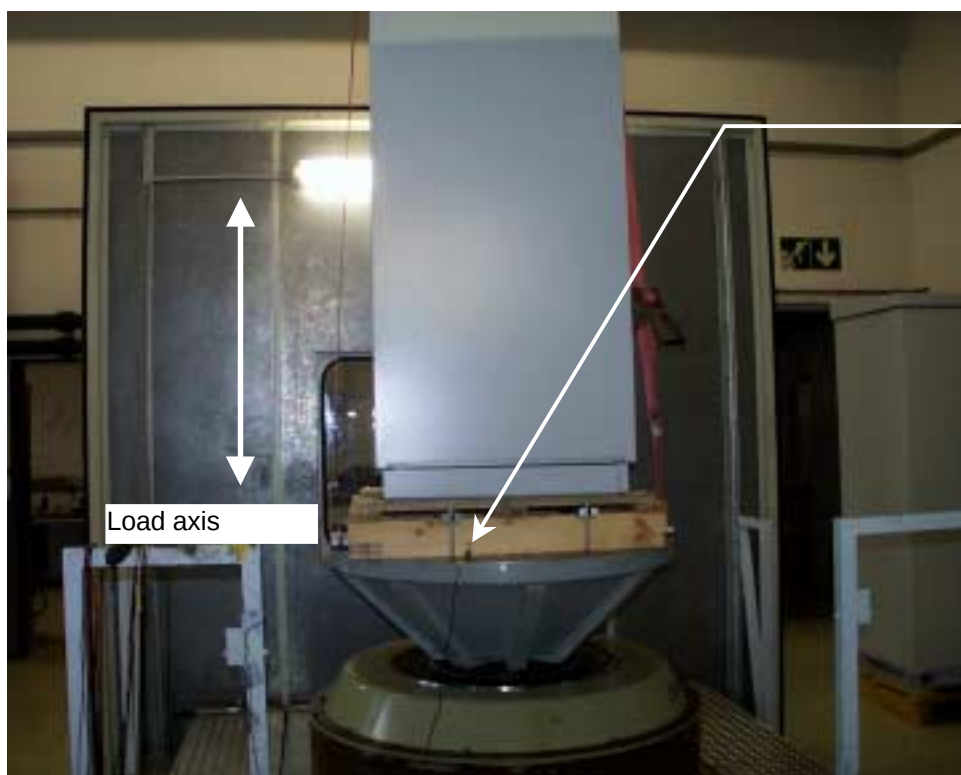
Picture 3

| Test | Ref. | Axis/Set-up | Type of Strain / Remarks | Time / Doc. |
|---|---|---|---|---|
| # 3 | 2.1 | Z axis<br>(Picture 3) | Vibration - sinusoidal, 10 cycles<br>Acceleration procedure control channel | 2:23:41 h<br>Enclosure 3 |
| Visual control inside and out<br><u>Result:</u> No damage detectable | | | | |
| # 4 | 2.2 | Z axis<br>(Picture 3) | Mechanical Shock<br>Acceleration procedure control channel + direction<br>Acceleration procedure control channel + direction<br><u>Remark:</u> Due to extremely strong reaction of the tested item,<br>the tolerances of the IEC 68-2-27 could not be adhered to. | 2:23:41 h<br>Enclosure 4<br>Enclosure 5 |

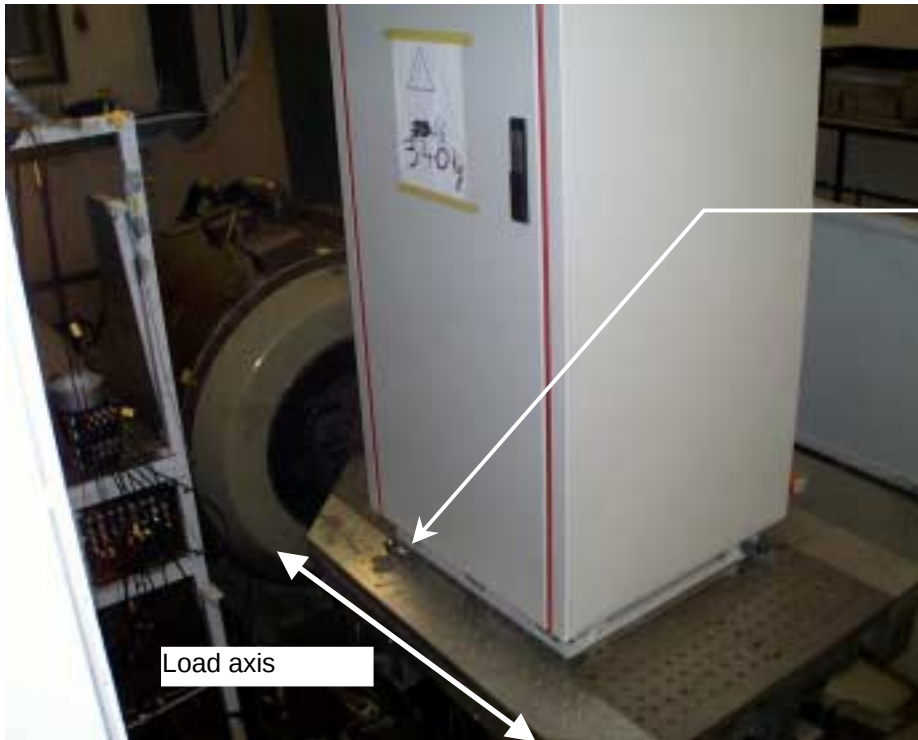
Picture 4

| Test | Ref. | Axis/Set-up | Type of Strain / Remarks | Time / Doc. |
|---|---|---|---|---|
| # 6 | 2.3 | Z axis<br>(Pictures 4+3) | Seismic test, duration of time<br>Acceleration procedure control channel, time signal<br>Acceleration procedure control channel, amplitude spectrum | 15 shocks, 30 s in total<br>Enclosure 6<br>Enclosure 7 |
| Visual control inside and out<br><u>Result:</u> No damage detectable | | | | |
| # 7 | 2.3 | Y axis<br>(Pictures 4+2) | Seismic test, duration of time<br>Acceleration procedure control channel<br>Acceleration procedure control channel, amplitude spectrum | 15 shocks, 30 s in total<br>Enclosure 8<br>Enclosure 9 |
| # 8 | 2.3 | X axis<br>Pictures 4+1) | Seismic test, duration of time<br>Acceleration procedure control channel<br>Acceleration procedure control channel, amplitude spectrum | 15 shocks, 30 s in total<br>Enclosure 10<br>Enclosure 11 |

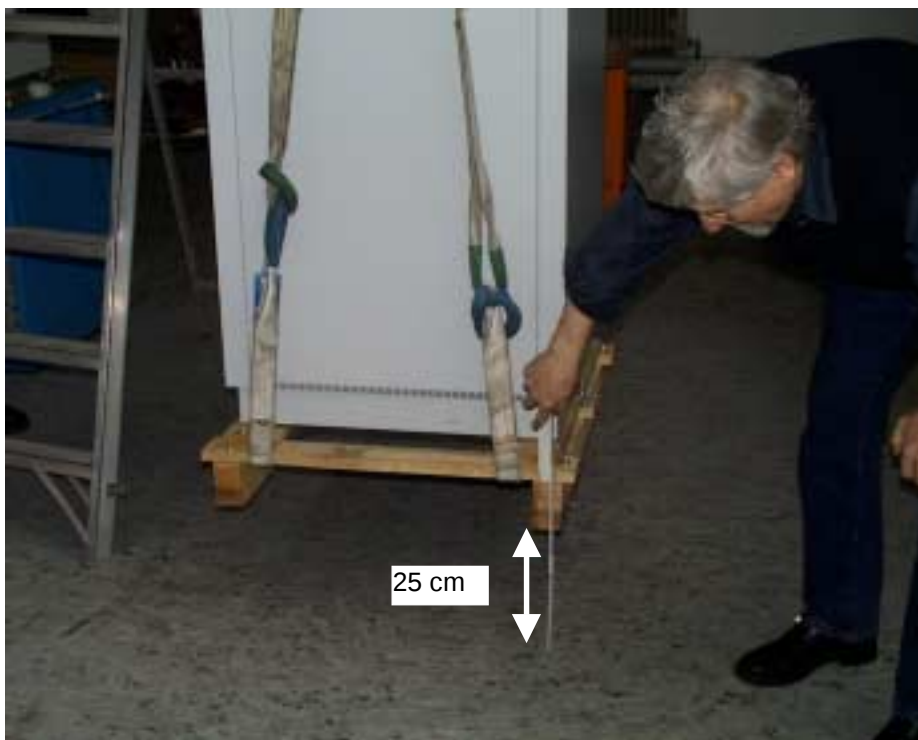
Picture 5

| Test | Ref. | Axis/Set-up | Type of Strain / Remarks | Time / Doc. |
|---|---|---|---|---|
| # 5 | 2.4 | vertical<br>(Picture 5) | Free fall | 1 fall |
| Visual control inside and out<br><u>Result:</u> No damage detectable | | | | |

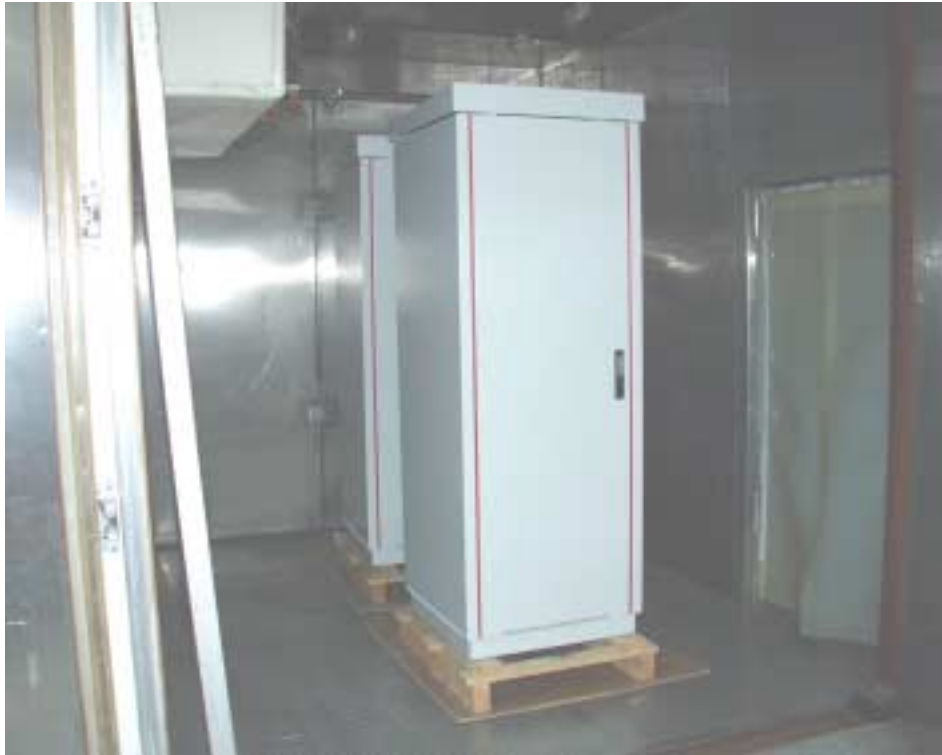
| Test | Ref. | Axis/Set-up | Type of Strain / Remarks | Time / Doc. |
|---|---|---|---|---|
| # 9 | 2.21 | Picture 8 | Constant cold - 45°C, 16h<br>Temperature progressing<br><br>Visual control inside and out<br><u>Result:</u> No damage detectable | 22nd - 23rd March 2002<br>Enclosure 12 |
| # 10 | 2.22 | Picture 8 | Dry heat +80°C, 16h<br>Temperature progressing<br><br>Visual control inside and out<br><u>Result:</u> No damage detectable | 23rd March 2002<br>Enclosure 13 |
| # 11 | 2.23 | Picture 8 | Temperature change -50°C / +23°C, 2 cycles<br>Temperature progressing<br><br>Visual control inside and out<br><u>Result:</u> No damage detectable | 25th to 26th March 2002<br>Enclosure 14 |
| # 12 | 2.24 | Picture 8 | Humid heat, constant<br>Temperature progressing<br><br><b>Remark :</b> The relative humidity was controlled with the temperature of the water bath and was checked manually with a humidity psychrometer.<br><br>Visual control inside and out<br><u>Result:</u> No damage detectable | 26th to 30th March 2002<br>Enclosure 15 |
| # 13 | 2.25 | Picture 8 | Humid heat, cyclic<br>Temperature progressing<br><br><b>Remark :</b> The relative humidity was controlled with the temperature of the water bath and was checked manually with a humidity psychrometer.<br><br>Visual control inside and out<br><u>Result:</u> No damage detectable | 2nd to 6th April 2002<br>Enclosure 16 |
