TCG NEBS COMPLIANCE TEST REPORT FOR:

Product: Outdoor Model 42U700x700

PART: 23 EARTHQUAKE, OFFICE VIBRATION, AND TRANSPORTATION VIBRATION

Section 4.4, GR-63-CORE Telcordia Technologies GR-63, Issue 4, April 2012

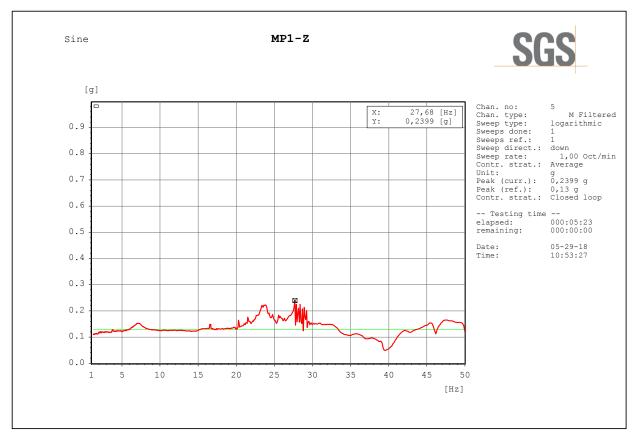
Fig. 23-18 Resonance search: excitation in z-dir.; top of the rack

lowest natural gross frequency for excitation in z-direction: no results in the examined frequency range
