Center for Quality Engineering

Test Report No.: T1AY0001

Equipment Under Test: ACTA-Prototype

Task: Fire Spread Test

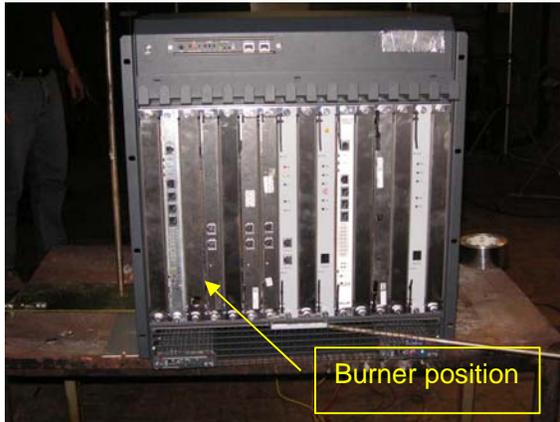
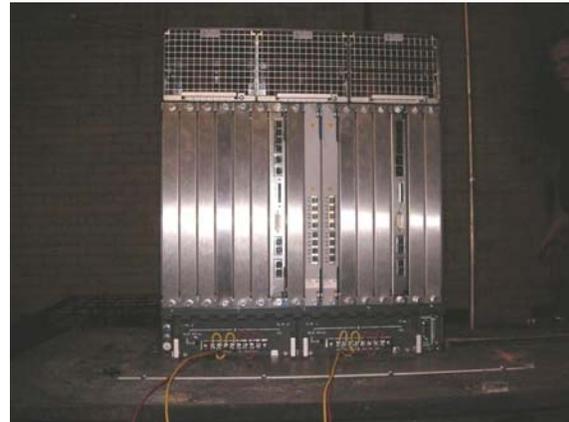
Pic. 1 : Front View

Pic. 2 :Back View

All tests are performed with slot covers and partly assembled with original PCB's. The slot cover are covering additional the vertical air flow between the board.

The start of the test was rather difficult. The very strong dominating air flow inside the ducts are extinguishing the the flame. It was only possible to start the test with a gas flow with 6 l/min and a covered air out let of the rear side. After the flame stablisation inside the shelf we are removing slowly the cover at the air outlet.

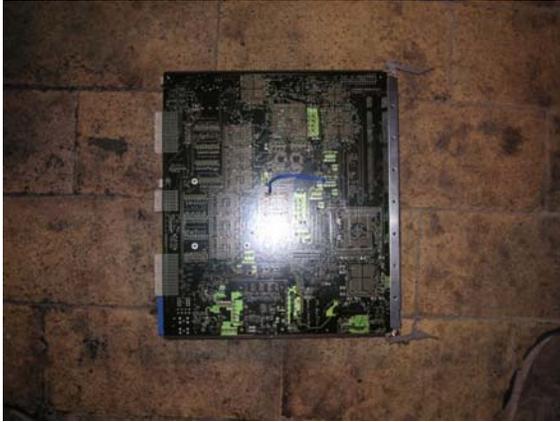
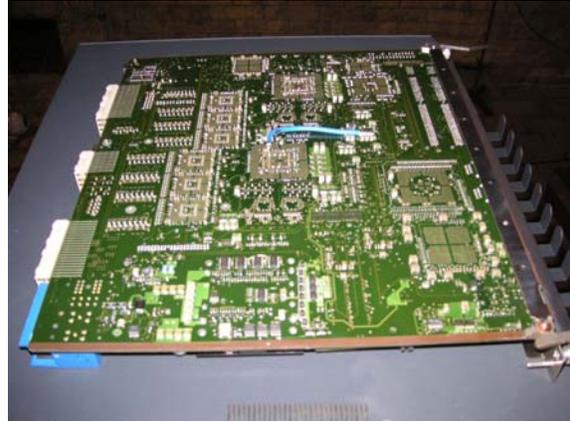
Pic. 3 : Neighbour board after Test 1

Pic. 4 : Neighbour board after Test 1

There are no burning tracks on the neighbour boards visible.

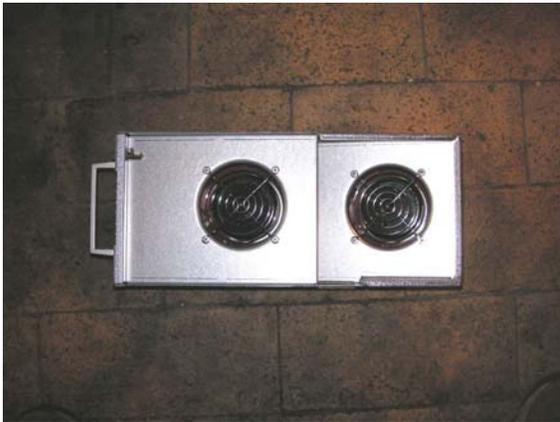
Pic. 5 : Fan-Modul after first test

The inlet fan filter was burned by the test flame. The very high inlet air flow are soaking the flame out of the hole into the main air intake and finally into the fan filter.

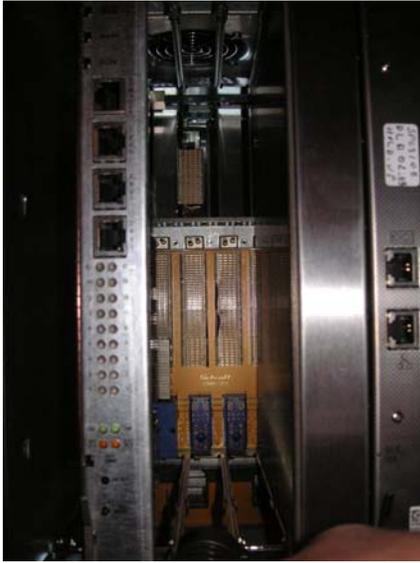
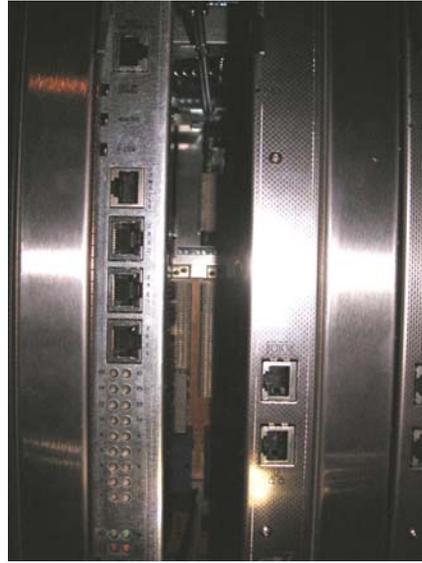
Test was a rerun of test 1. The slot cover was replaced by a simple face plate. The face plate was covering only the front side. The air flow will not be disturbed.

Pic. 6 : Slot after test

Pic. 7 : Slot after test

There are no burning tracks on the neighbour boards visible.

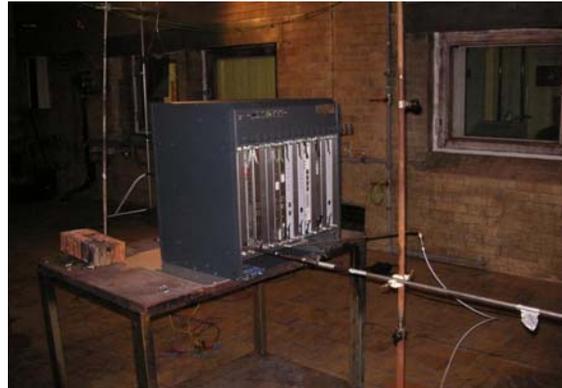
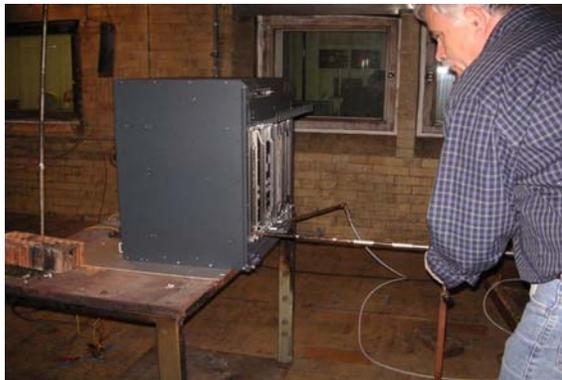
Pic. 9 : experiment set-up

Pic. 10 : Positioning of the line burner

The burner position was at slot 1 (from the left side).

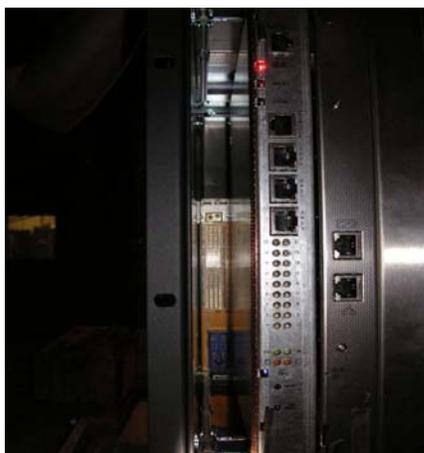
Pic. 11 : Slot after test

There are no burning tracks on the neighbour boards visible.

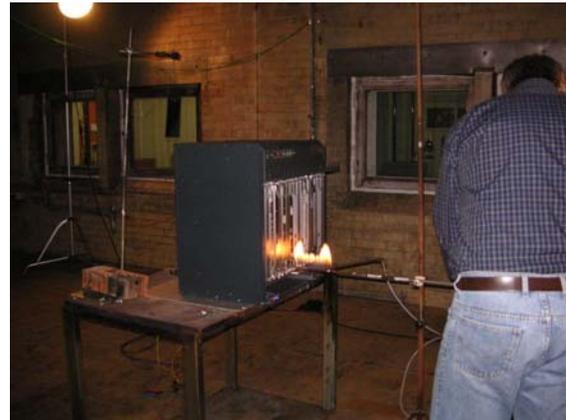
Pic. 13 : Line burner set-up

The burner was located between fans to consider the different air flow conditions.

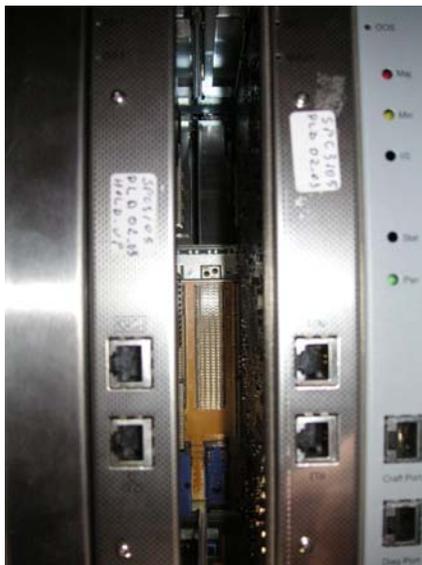
Pic. 14 : Slot after test

There are no burning tracks on the neighbour boards visible.

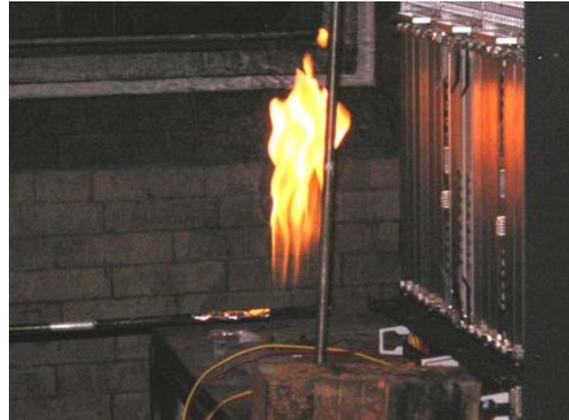
Pic. 16 : Line burner partly covered

The dept of the rear compartment was smaller than the length of line burner. We have covered 50% of the burner holes the gas flow was not reduced.

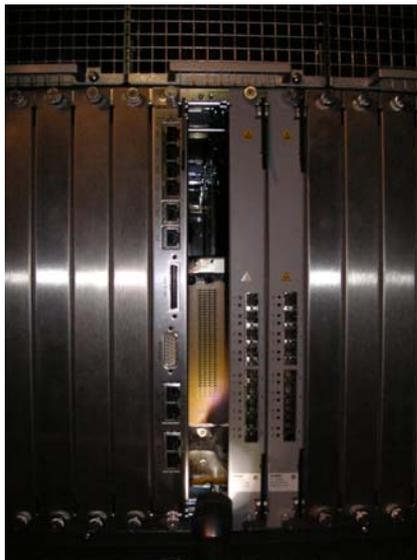
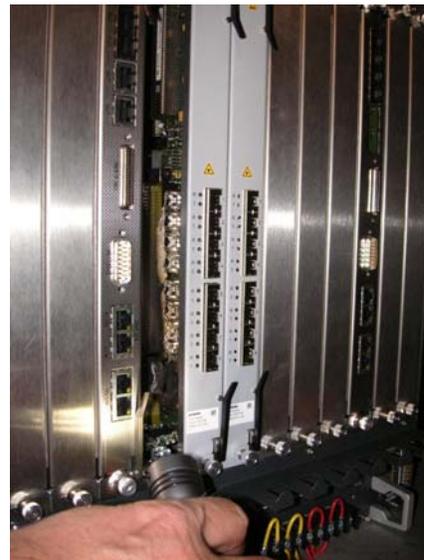
Pic. 17 : Neighbour boards

Pic. 18 : Neighbour board

There are only small burn traces visible at the neighbour boards.

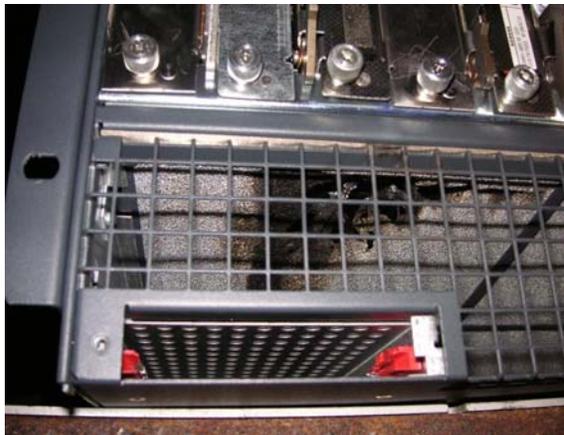
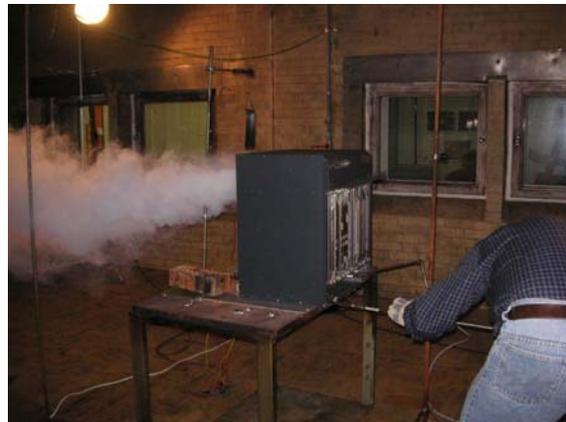
Pic. 20 : Fan Filter

Pic. 21 : Filter burning
