Release Notes

nVent/Schroff firmware part number 63998-53474

Based on Pigeon Point Systems (PPS) firmware release V3.7.1.4 for ShMM-700

Release Date: April 17, 2019

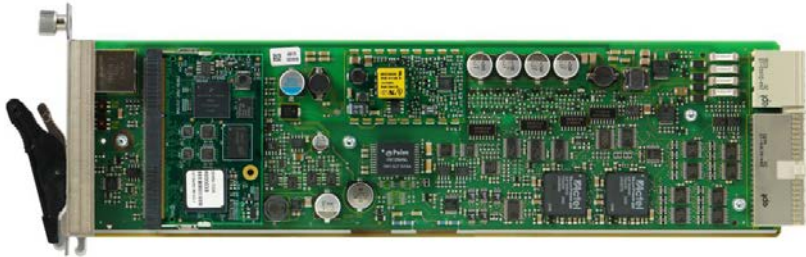
Photo	Type	RC2-variable

The table below shows the nVent/Schroff shelf manager versions, please identify your shelf manager type. You will need the corresponding RC2-variable later in the upgrade process.
