## Release Notes

**nVent/Schroff firmware part number 63998-53476**

**Based on Pigeon Point Systems (PPS) firmware release V3.7.1.6 for ShMM-700**

**Release Date: April 7, 2020**

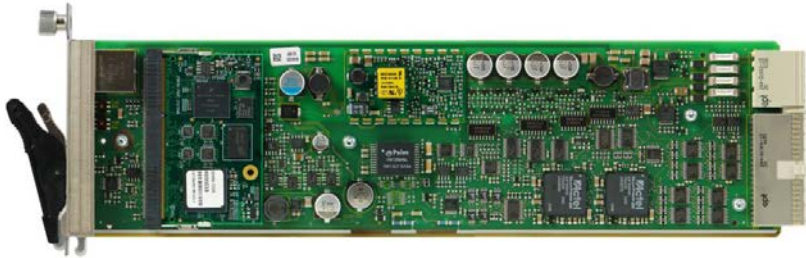
Photo	Type	RC2-variable

The table below shows the nVent/Schroff shelf manager versions, please identify your shelf manager type. You will need the corresponding RC2-variable later in the upgrade process.

<p>- Bused IPMB version: P/N = 21990-401 - Radial IPMB version: P/N = 21990-402</p>	ACB-VI	rc.acb6-HPDL
