**Release Notes**  
**nVent/Schroff firmware part number 63998-53474**  
**Based on Pigeon Point Systems (PPS) firmware release V3.7.1.4 for ShMM-700**

The firmware package “63998-53474.zip” contains Firmware release V3.7.1.4 for the **ShMM-700**. The PPS supplied APP image has been modified by nVent/Schroff to adapt the firmware to nVent/Schroff ATCA shelves. The kernel and RFS images have not been modified and are identical to the PPS kernel and RFS images. The U-boot environment has been modified to reflect the necessary non-volatile system settings for this firmware running on nVent/Schroff shelf managers. The nVent/Schroff part number for this firmware release is 63998-53474.

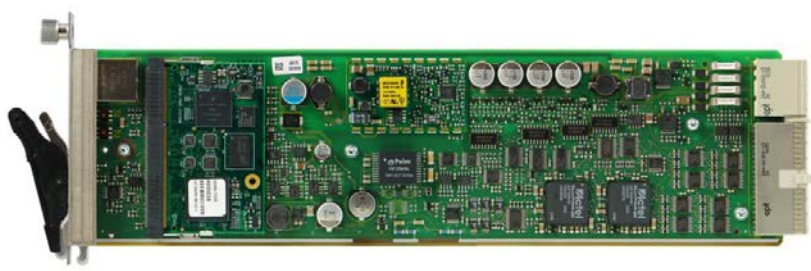
The table below shows the nVent/Schroff shelf manager versions, please identify your shelf manager type. You will need the corresponding RC2-variable later in the upgrade process.

Photo	Type	RC2-variable
<div style="text-align: center;">

</div> <ul style="list-style-type: none"> <li>- Bused IPMB version: P/N = 21990-401</li> <li>- Radial IPMB version: P/N = 21990-402</li> </ul>	ACB-VI	rc.acb6-HPDL
