Test Report No.: T1630001

Client:	Schroff SAS R&D Cabinets and Cases
Equipment Under Test:	Cabinet Varistar SL Bellcore4 - 3xATCA
Manufacturer:	Schroff SAS
Task:	Earthquake-Testing
Test Specification(s): [covered by accreditation]	ETSI EN 300 019-2-3 V2.2.2 (2003-04) Earthquake
Result:	The EUT was subject to the tests listed in detail in ch. 6 of this report and complies with the corresponding requirements.

Cabinet Varistar SL Bellcore – 3xATCA

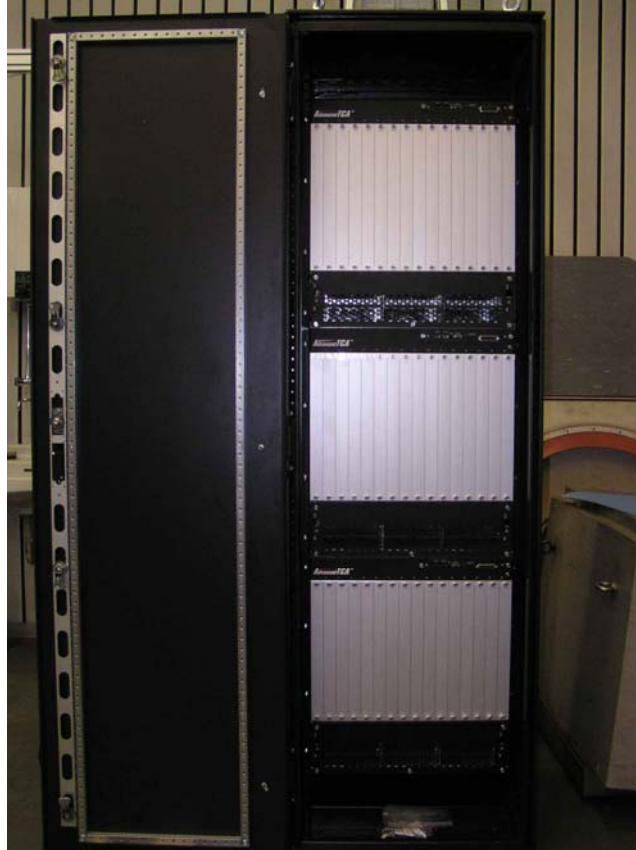
Completed with 3 ATCA-shelves as dummy weights

Weight: 444Kg

Pic. 1: Cabinet Varistar SL Bellcore – 3xATCA

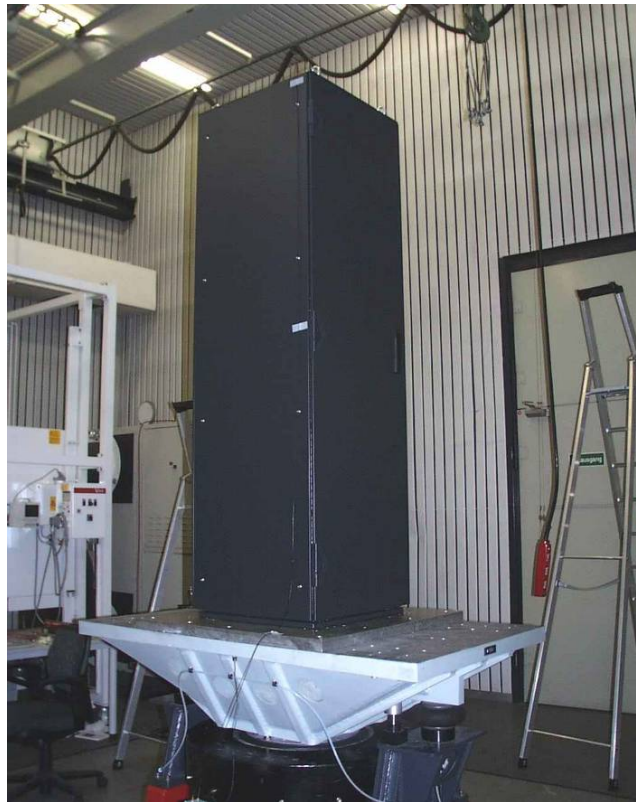
Before execution of the main earthquake tests a vibration response investigation (resonance search) was performed on the electro dynamic vibration system VIB 9000 in 3 mutually perpendicular axes with the following parameters:

Frequency Range:	1.5 to 35 Hz
Acceleration:	2 m/s ²

Pic. 2 Mounting of EUT Z-Axis (Vibration Response Investigation)e

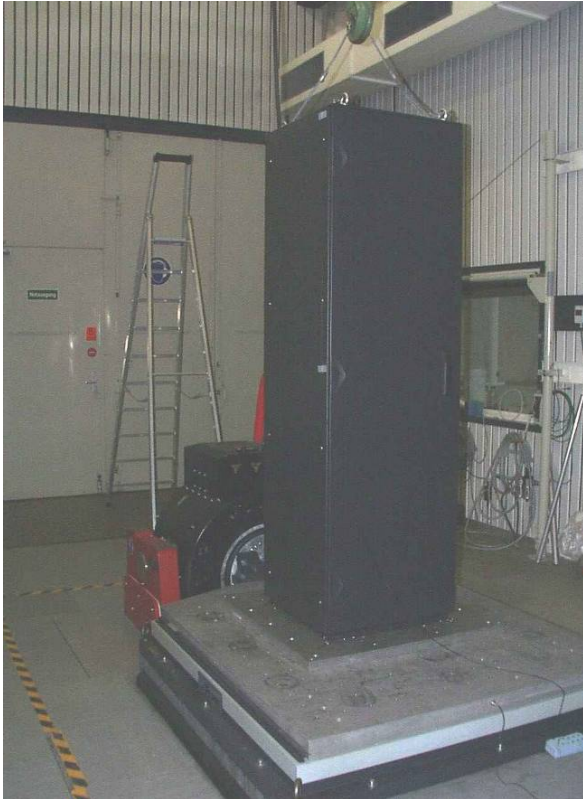
Pic. 3 Mounting of EUT X-Axis (Vibration Response Investigation)

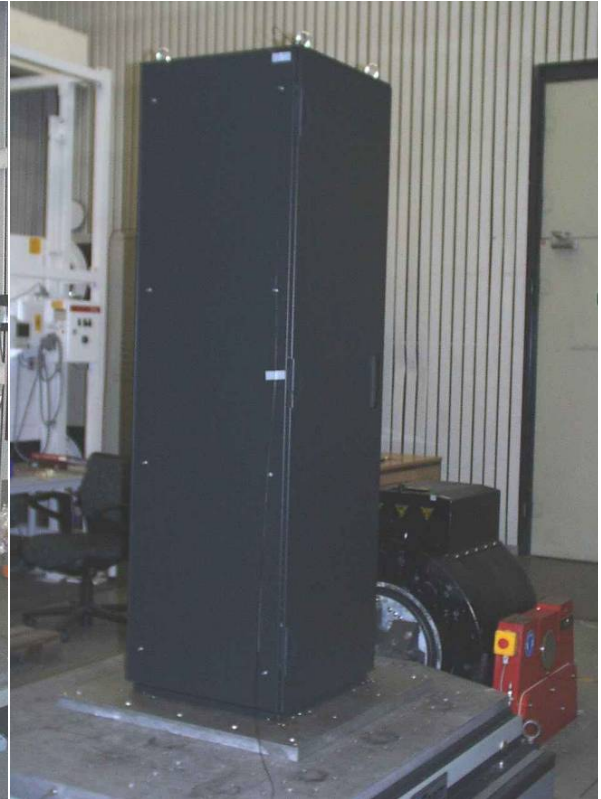
Pic. 4 Mounting of EUT X-Axis (Vibration Response Investigation)Example

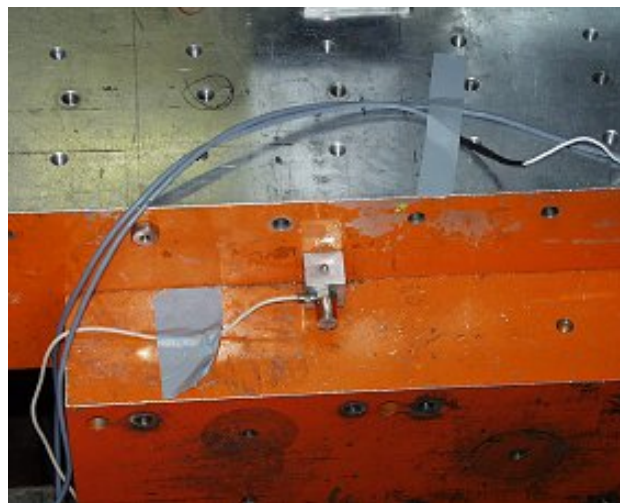
Control point in direction of excitation and recording the time history over a time of 35 sec

Pic. 5 Measuring point – earthquake table

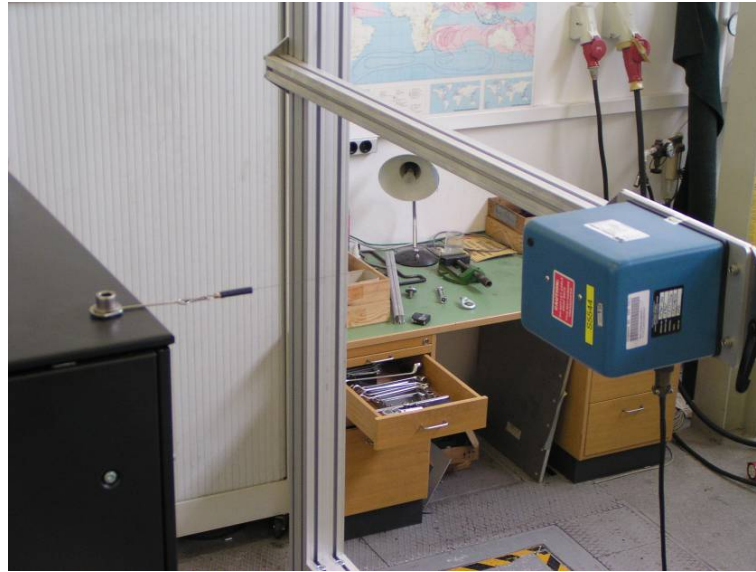
At The top of the EUT a measuring equipment were mounted to destinate displacement in sensing direction.

Pic. 6 Measuring equipment LVT for displacement

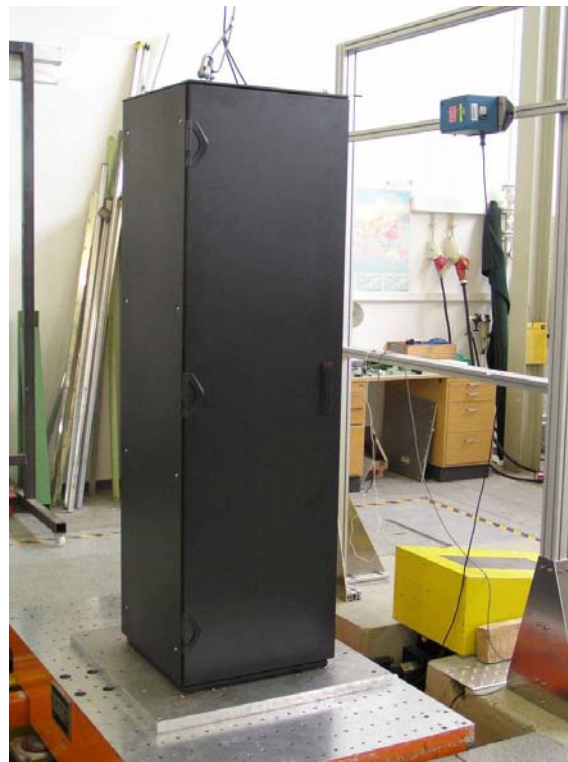
The EUT were mounted to the earthquake table in its normal use position on a aluminum plate of 40mm thickness.

Pic. 7 EUT mounted on the earthquake table

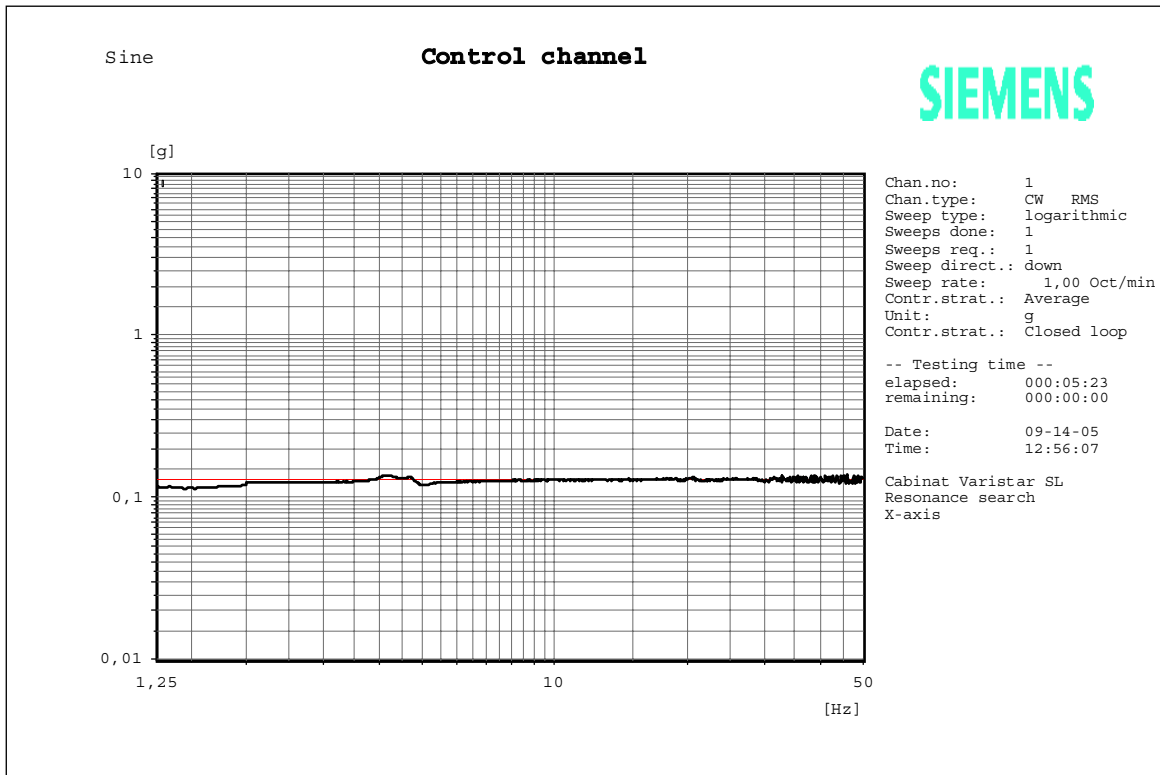
Figure 6.1: Acceleration at Vibration Table (X-Axis)

Axis	Frequency [Hz]
X	4.66
Y	6.5
Z	36.9

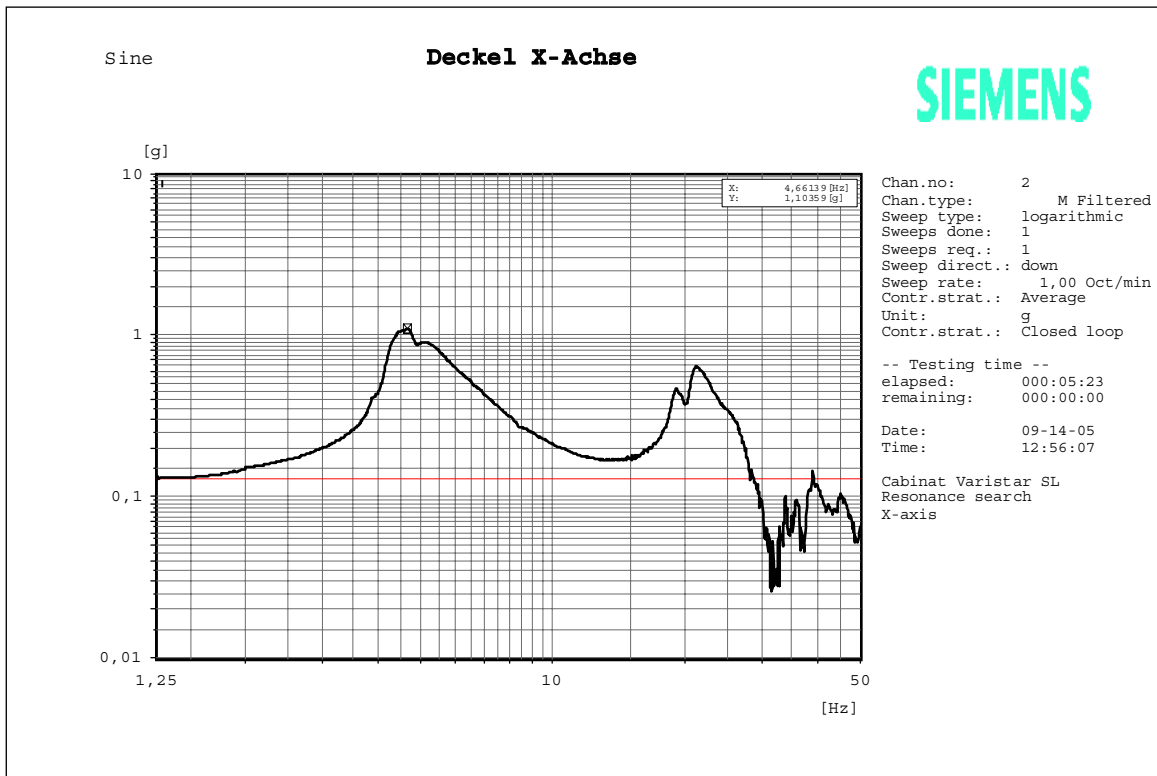
Figure 6.2: Vibration Response at the Top of EUT (X-Axis)

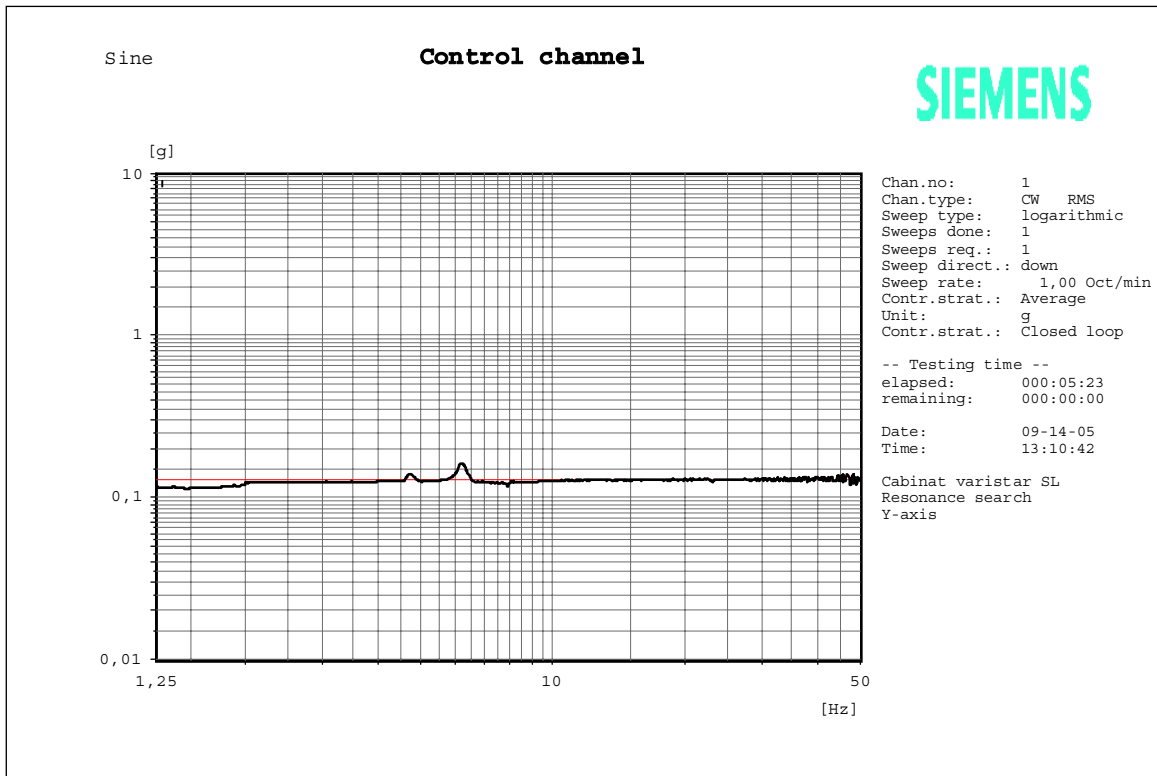
Figure 6.3: Acceleration at Vibration Table (Y-Axis)

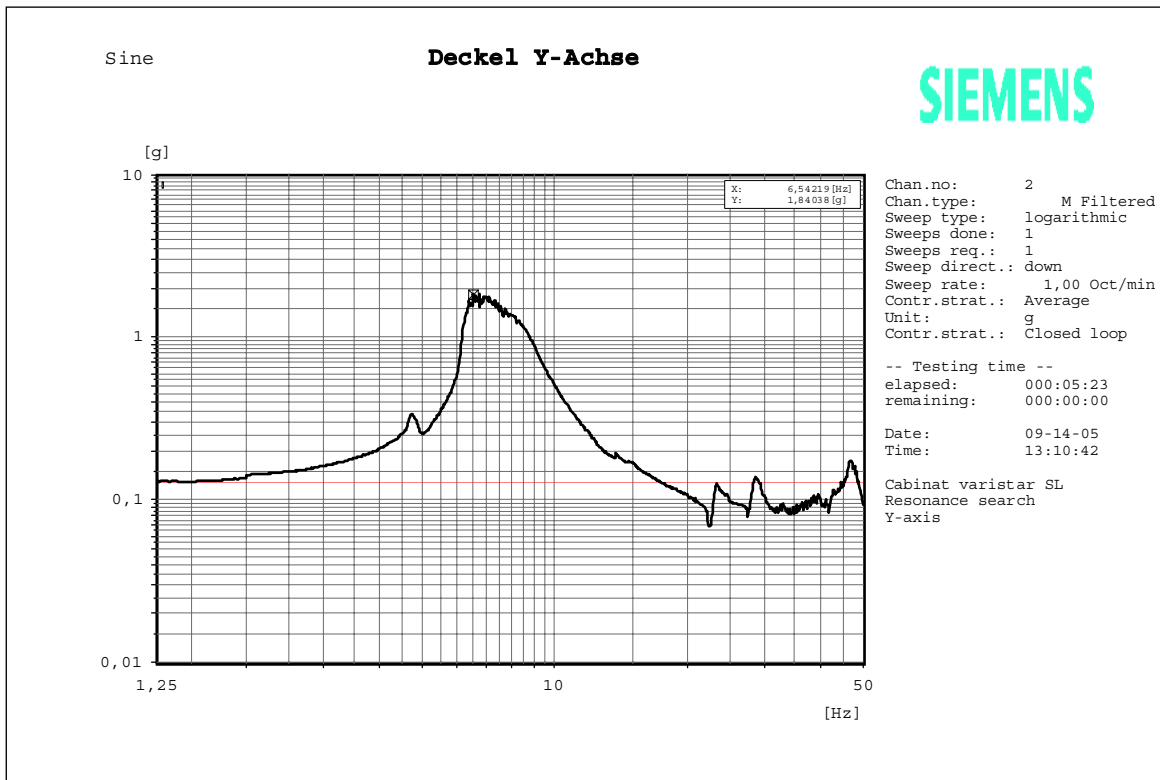
Figure 6.4: Vibration Response at the Top of EUT (Y-Axis)

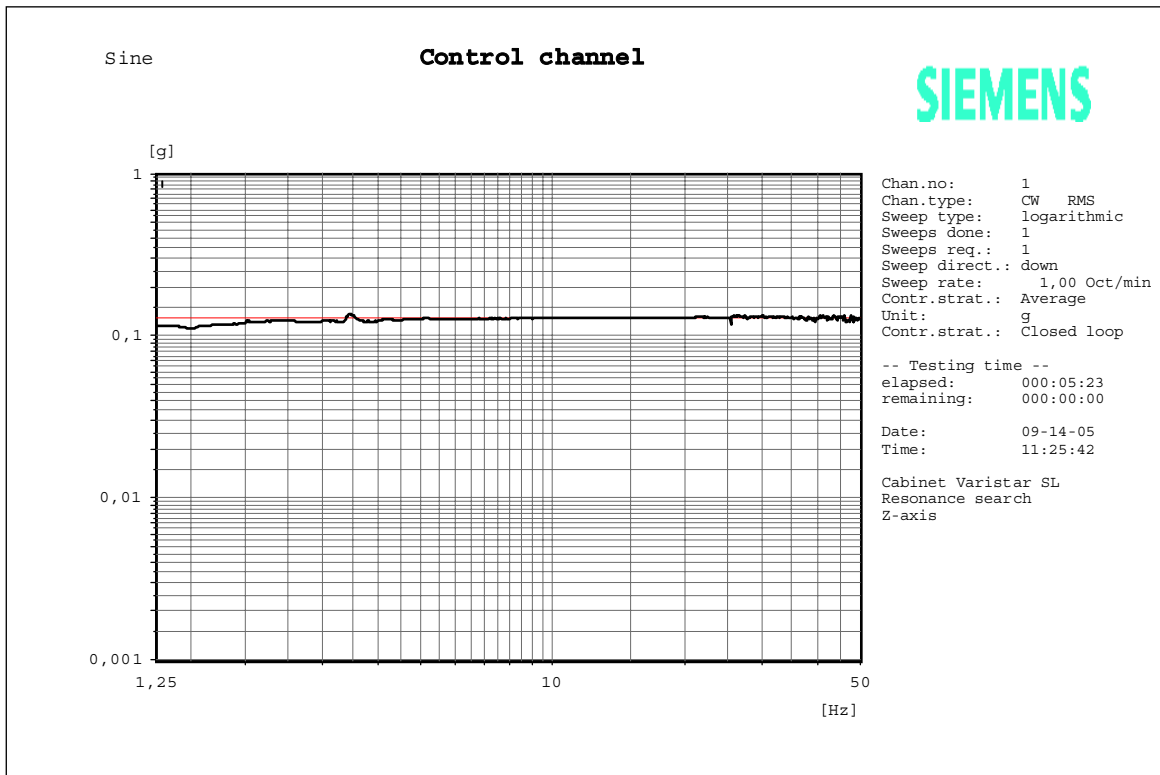
Figure 6.5: Acceleration at Vibration Table (Z-Axis)

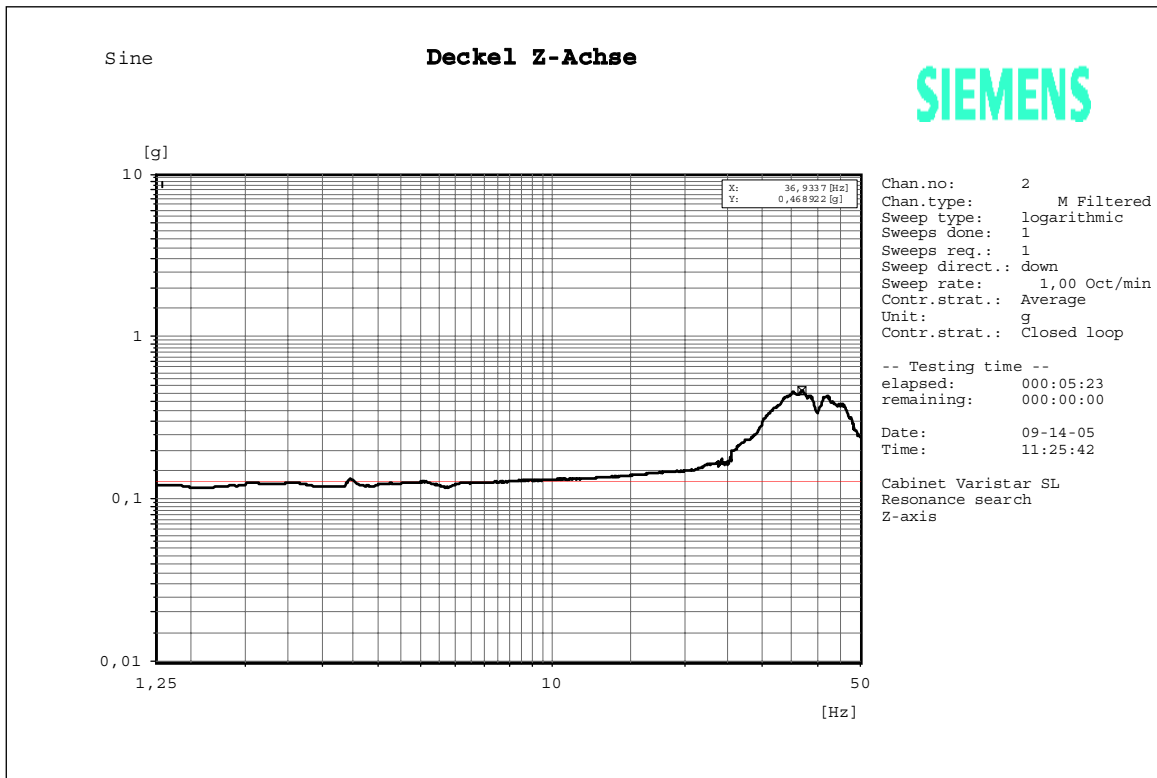
Figure 6.6: Vibration Response at the Top of EUT (Z-Axis)

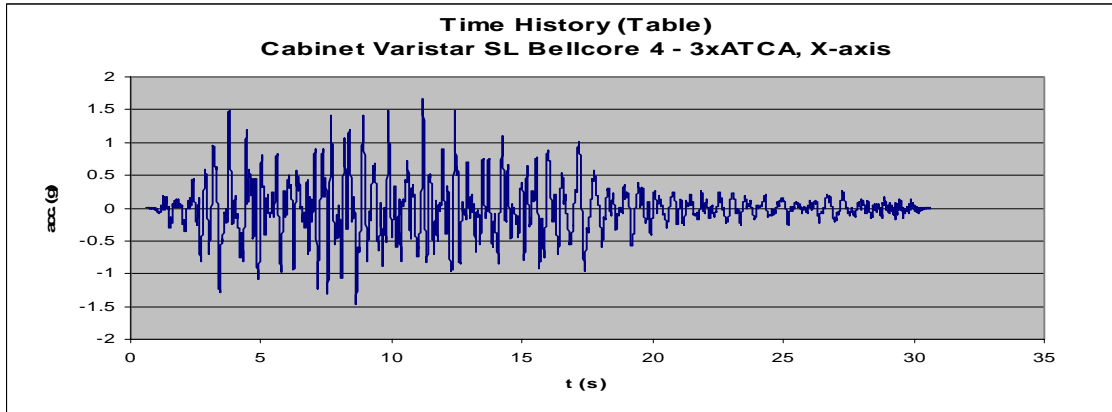
Figure 6.7: Acceleration at Earthquake Table (X-Axis)

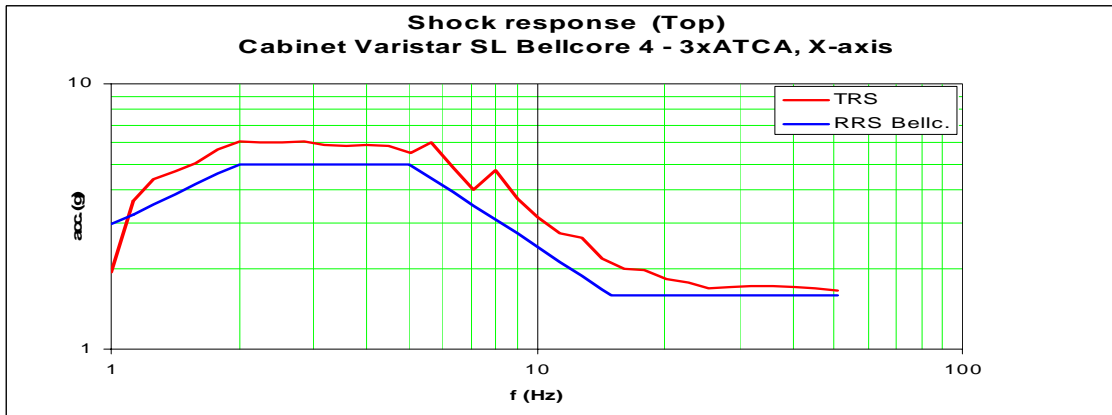
The shaker table's analysed acceleration, known as Test Response Spectrum (TRS, red line), must meet or exceed the Required Response Spectrum (RRS, blue line) for the Earthquake Risk Zone 4 in the range from 1.0 to 35 Hz.

Figure 6.8: Test Response Spectrum (X-Axis)

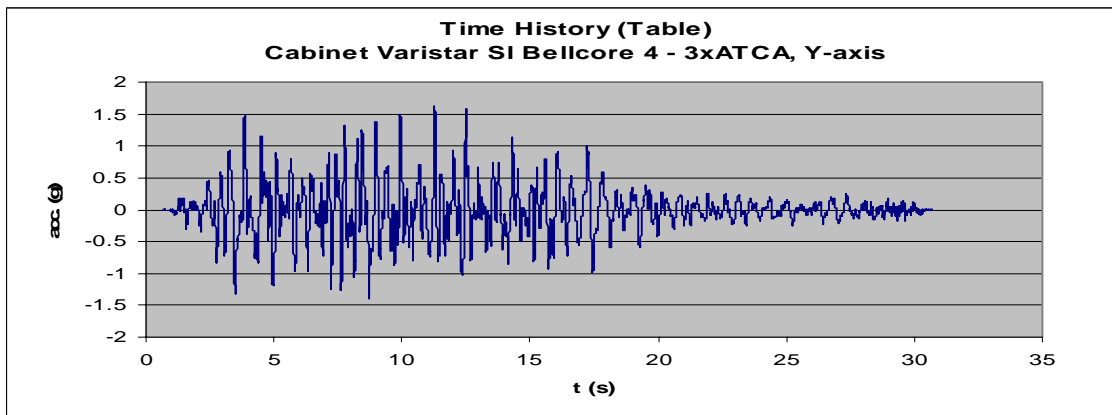
Figure 6.9: Acceleration at Earthquake Table (Y-Axis)

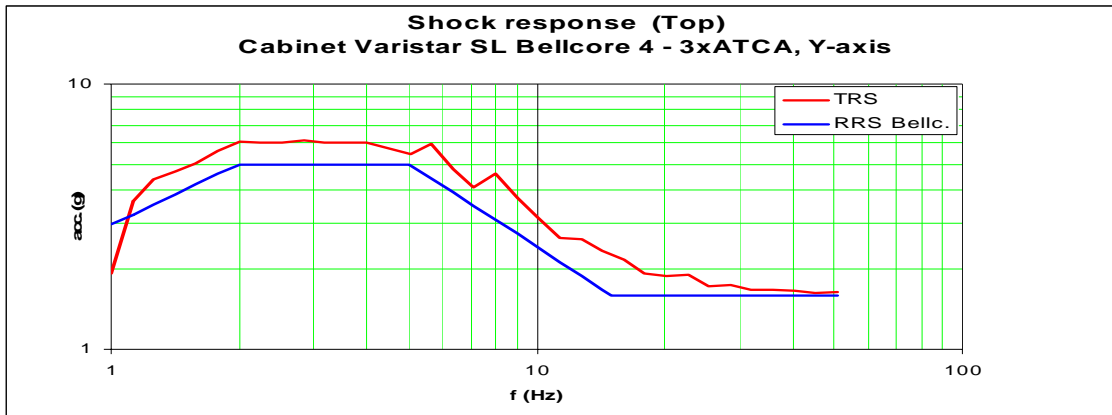
Figure 6.10: Test Response Spectrum (Y-Axis)

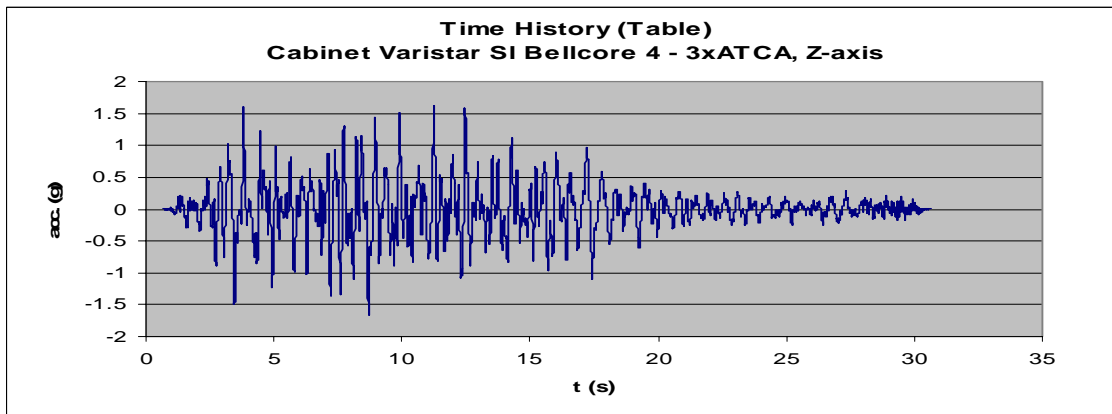
Figure 6.11: Acceleration at Earthquake Table (Z-Axis)

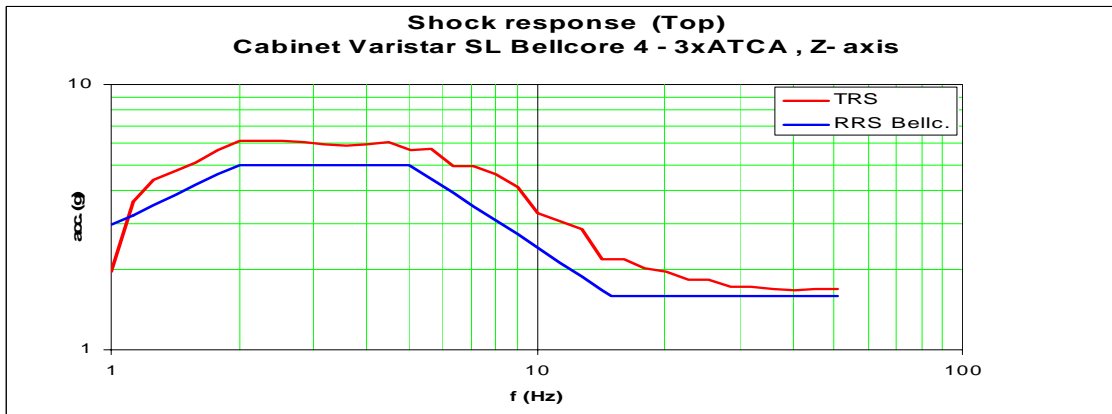
Figure 6.12: Test Response Spectrum (Z-Axis)

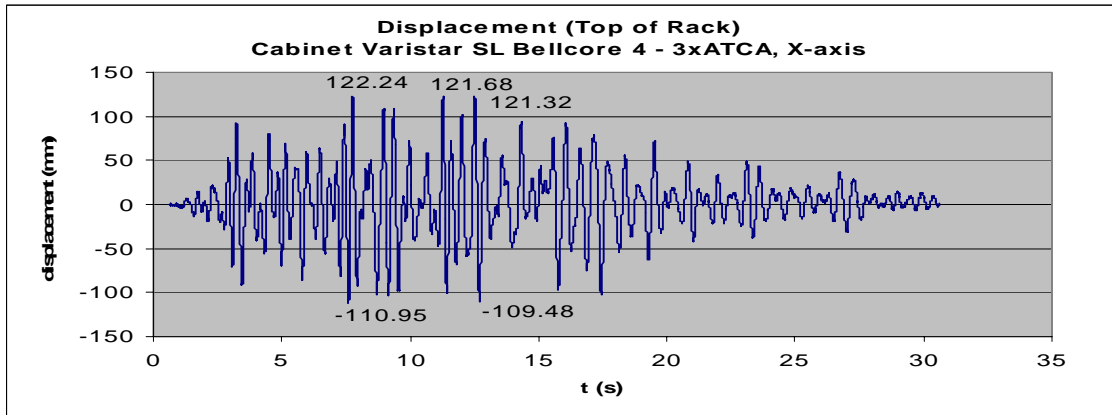
Figure 6.13: illustrates the displacement at top of EUT X-axis

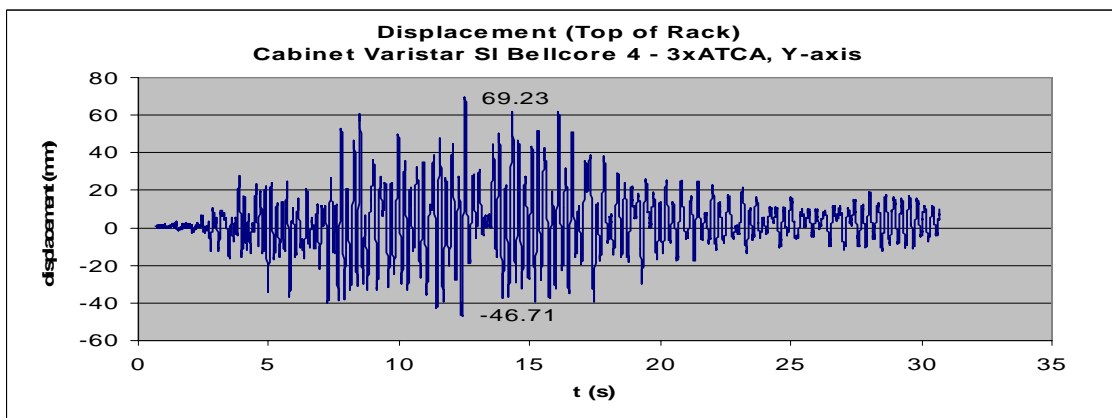
Figure 6.14: illustrates the displacement at top of EUT Y-axis
